SCH3227/SCH3226/SCH3224/SCH3222 Silicon Errata and Data Sheet Clarification

SCH322X

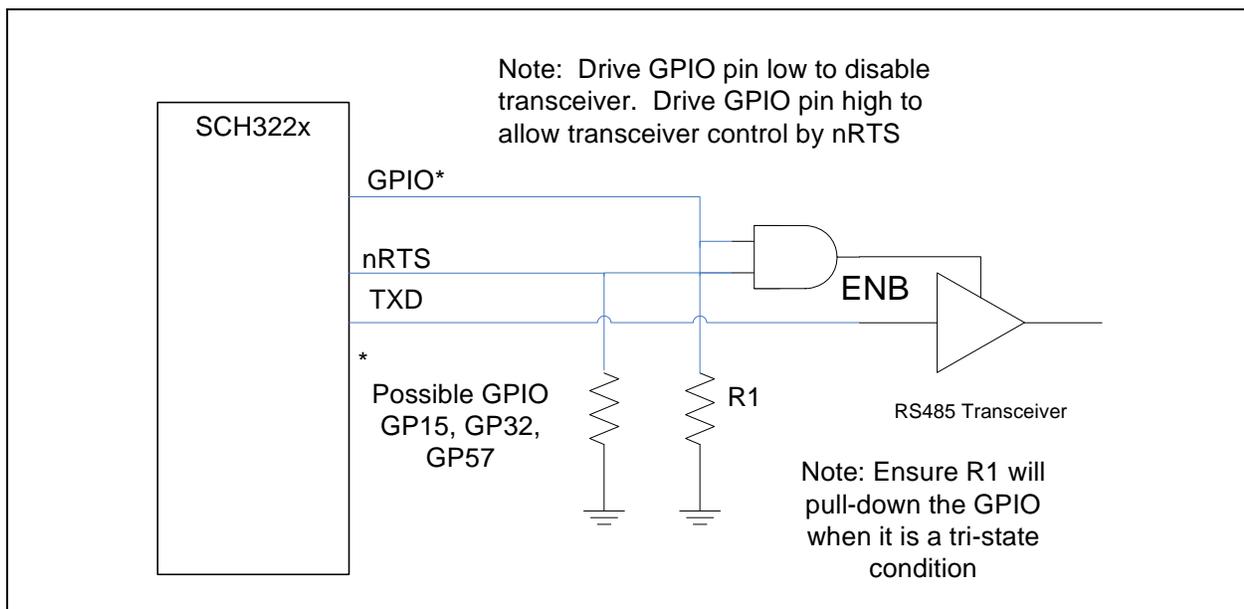
1. Module: Serial Port

UART 3 and UART 4 do not tri-state their outputs on a PCI_RESET as do UART 1 and UART 2.

UART 3 and UART 4 outputs are not controlled by the Configuration Register 0x30 ACTIVATE bit.

UART 3 and UART 4 outputs will drive High when PCI_RESET goes active or when the ACTIVATE bit is cleared, and if the platform uses RTS to control an RS485 transceiver this may interrupt communication.

Use GPIO pin to disable RS485 transceiver when ACTIVATE bit is cleared.
