This errata sheet provides updated information on known device issues affecting Cyclone® IV devices.

Table 1 lists specific Cyclone IV issues, and which Cyclone IV devices are affected by each issue.

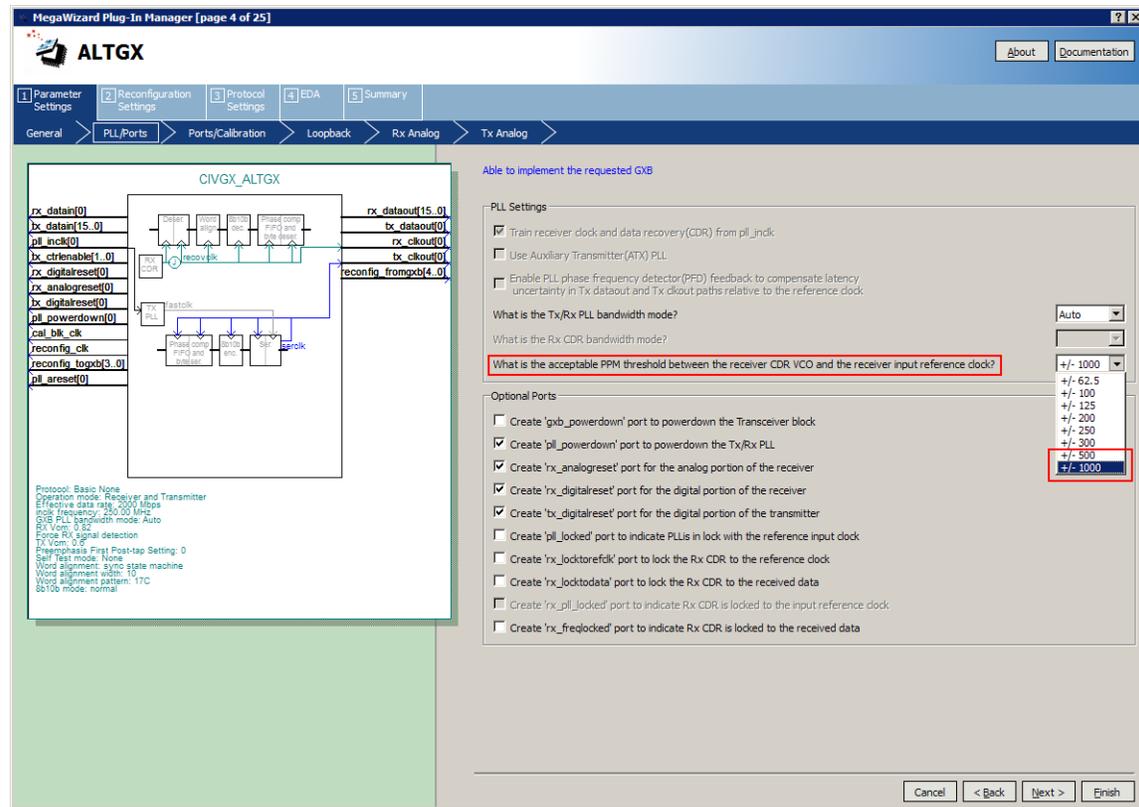
Figure 1. Programmable PPM Detector Options in the ALTGX MegaWizard Plug-In Manager

The ±500 PPM and ±1000 PPM options for the Programmable PPM Detector feature in the ALTGX MegaWizard™ Plug-In Manager, as shown in [Figure 1](#), are no longer supported in the Quartus II software version 10.0 SP1 and later. These options are removed because the programmed PPM threshold values exceed the receiver CDR PPM tolerance between the upstream transmitter reference clock and the local receiver reference clock.

Designs compiled with the Quartus II software version 10.0 and earlier may have a link failure risk when the receiver is operating in a system that has ± 500 PPM or ± 1000 PPM differences for the reference clock frequencies between the upstream transmitter and the local receiver. Using CDR Manual Lock mode does not overcome the link failure risk.

For a receiver design that has the ± 500 PPM or ± 1000 PPM options selected in the Programmable PPM Detector feature, Altera recommends evaluating the system operation with different options, ranging between ± 62.5 PPM and ± 300 PPM. To change the **Programmable PPM Detector** option, regenerate and recompile the ALTGX MegaWizard Plug-In Manager design file with the supported options.

If you compiled your designs using a Quartus II software version prior to 10.0 SP1, and you have selected the ± 500 PPM or the ± 1000 PPM option for the Programmable PPM Detector feature, the Quartus II Analysis and Synthesis error will be reported in the Quartus II software version 10.0 SP1 and later.
