# ***AM574x, AM576x Sitara™ Processors*** ***Silicon Revision 1.0***

## *Errata*

Literature Number: SPRZ447D  
JULY 2017 – REVISED FEBRUARY 2021

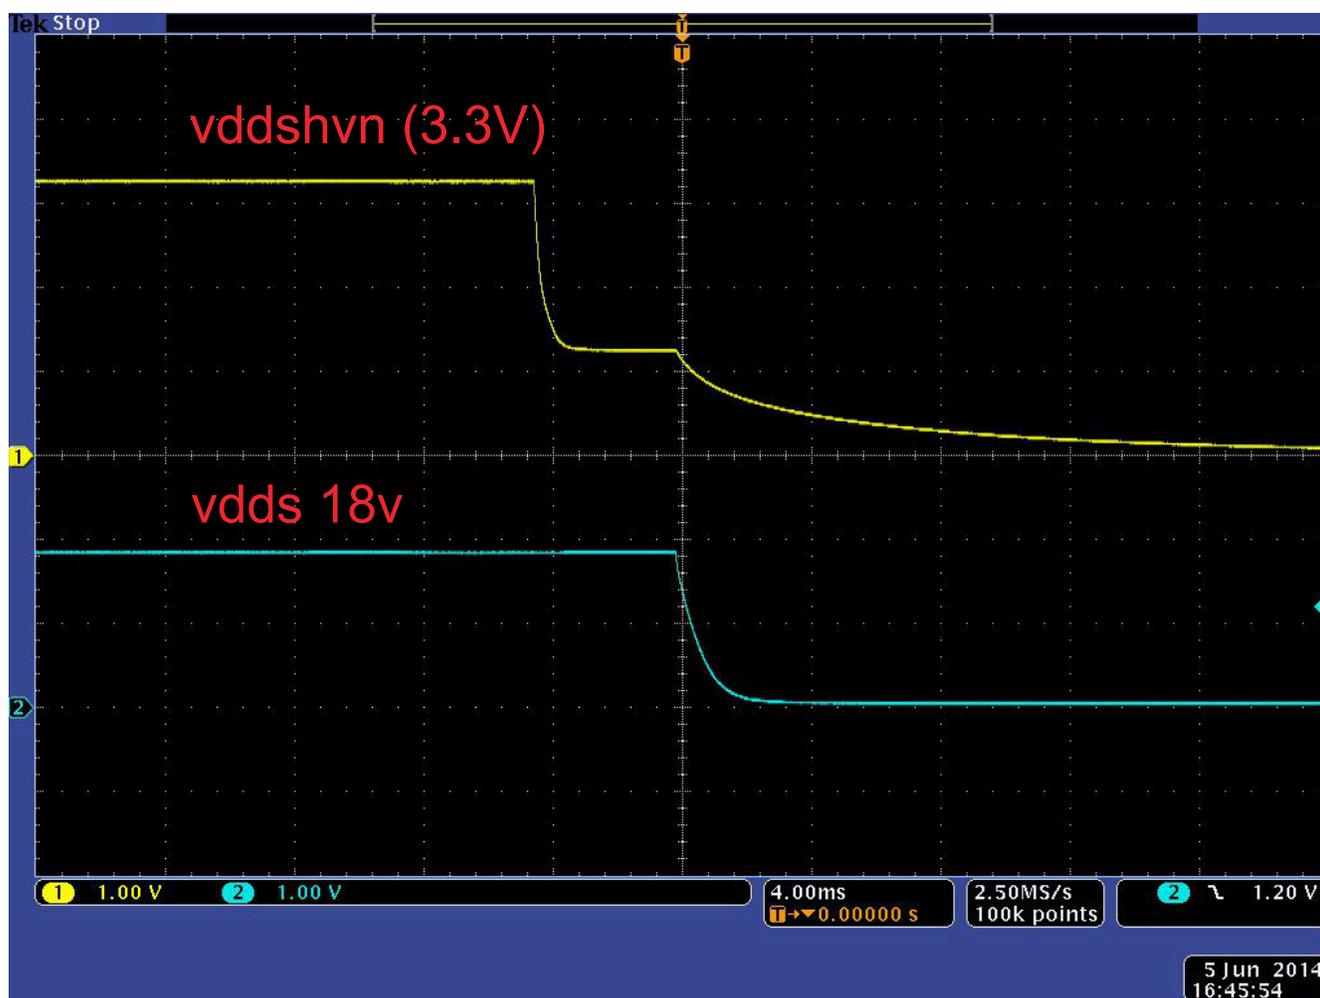
**Figure 4-1. PAB\_RevA**

The Data Manual allows the vddshvn rail (in either 3.3V or 1.8V mode) to power down at the same time or before the vdds18v rail. When the vddshvn rail is powered down before the vdds18v rail, the vddshvn rail stays at Plateau Level (<1.5V) until the vdds18v rail is disabled, as shown in the waveform below.

A subset of the SOC's LVCMOS IOs (refer to DM for details) have a pull-up resistor that is active by default, including during reset and power-down. The SOC's IOs that have internal or external pull-ups will stay at Plateau Level (<1.5V) during the power-down. If other ICs on the board that are interfaced to the SOC's LVCMOS signals use a separate supply then it's possible that the other IC's signals can be pulled to the Plateau Level while its power supply is off.

The root cause of the plateau is related to the LVCMOS IO buffer Dual Voltage detection circuitry. The LVCMOS Dual Voltage IO includes voltage comparator circuitry to determine if the IO is in 3.3V mode or 1.8V mode. During powerdown of vddshvn domains, a current path in the internal bias transistors results in the vddshvn rail being held to an

In general, TI recommends using the same supply source for connected components. E.g., a single LDO should drive vddshvn and the related 3.3V external components.

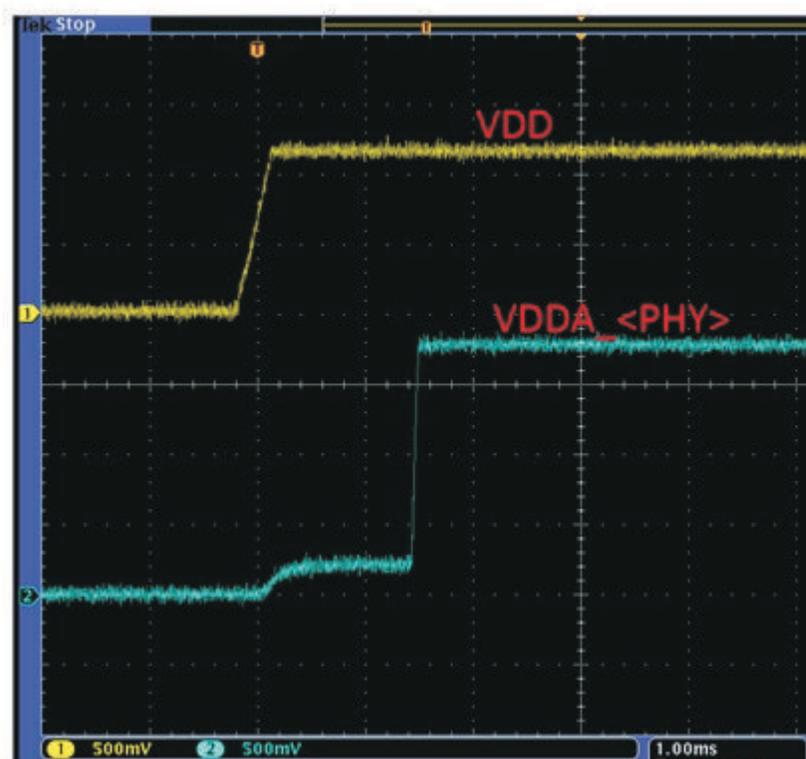
**Figure 4-2. Leakage Voltage**

**DESCRIPTION** A current path exists between VDD and the high speed analog PHY domain (VDDA\_HDMI, VDDA\_PCIE, VDDA\_SATA, VDDA\_USB2/3) during the supply power up and power down sequences.

The device-specific Data Manual requires Core AVS rail (VDD) to power up before the 1.8 V high speed analog PHY domain(s). When this sequence is followed, the high speed analog PHY domain will have a small step-up to a voltage plateau (< 0.5 V) that aligns to the beginning of the VDD ramp-up, and is maintained until the ramp-up of high speed analog PHY rail, as shown in [Figure 4-2](#). Note the leakage value will differ from system to system, but will be less than 500 mV. The leakage voltage in the provided capture is approximately 250 mV.

A similar condition exists during supply power down sequence. The high speed analog PHY domain(s) are required to be powered down prior to Core AVS rail (VDD), and may cause a small plateau to exist until Core AVS rail (VDD) is ramped down.

The root cause of the voltage plateau during power-up/down sequencing is related to the parasitic diodes in logic blocks which have multiple power sources. This leakage path is not a reliability concern for this device.
