This errata sheet provides updated information about known device issues affecting Stratix® IV GX devices.

Production Device Issues for Stratix IV GX Devices

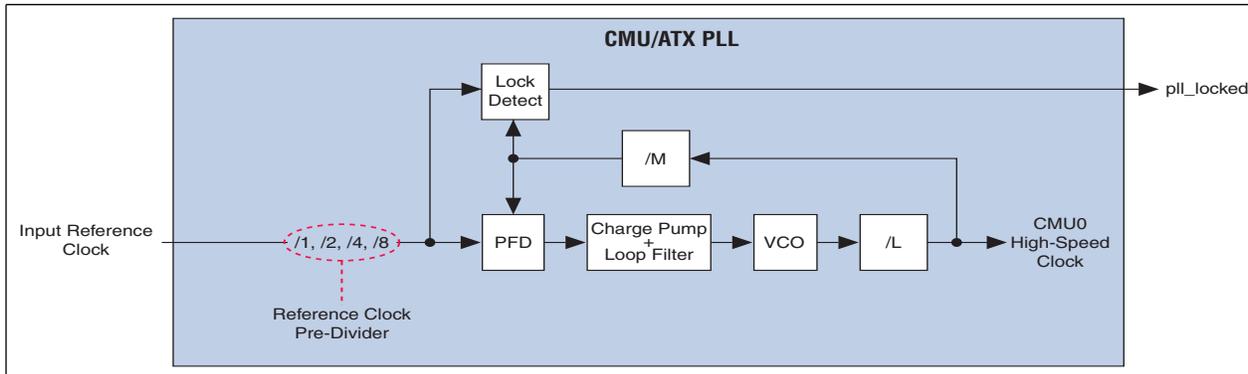
Figure 1. Reference Clock Pre-Dividers in Transmitter PLLs

The transmitter PLL lock status signal (pll_locked) does not deassert when the pll_powerdown signal is asserted in configurations that use the reference clock pre-divider of 2, 4, or 8. Figure 1 shows the reference clock pre-divider inside transmitter PLLs. This transmitter PLL lock status signal issue impacts the pll_locked status signal in both the CMU PLL and the ATX PLL.

Designs that implement the recommended transceiver reset sequence described in the *Reset Control and Power Down* chapter in volume 2 of the *Stratix IV Device Handbook* could potentially see a link failure after coming out of reset.

If the `pll_locked` issue impacts your design, instantiate and connect the `pll_locked_soft_logic` module, as shown in [Figure 3](#). Use the `pll_locked_to_corelogic` output from this module in the transceiver reset logic and any user logic that relies on the transmitter PLL lock status signal.

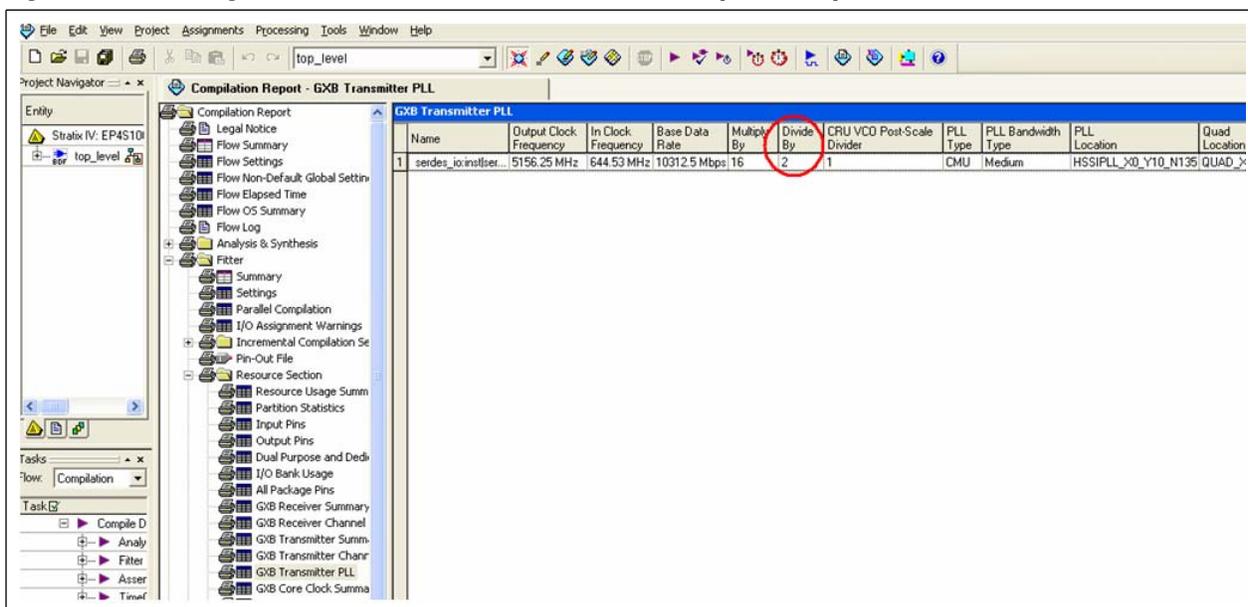
Figure 2. Determining Reference Clock Pre-Divider Value in the Compilation Report

You can determine whether the Transmitter PLL in your design uses a reference clock pre-divider of 2, 4, or 8 by referring to the Quartus II software Compilation Report. Figure 2 shows an example of the GXB Transmitter PLL report, which you find in the “Resources Section” under “Fitter” in the Compilation Report. If the value in the **Divide By** column reads 2, 4 or 8, your design is impacted by the pll_locked status signal issue.

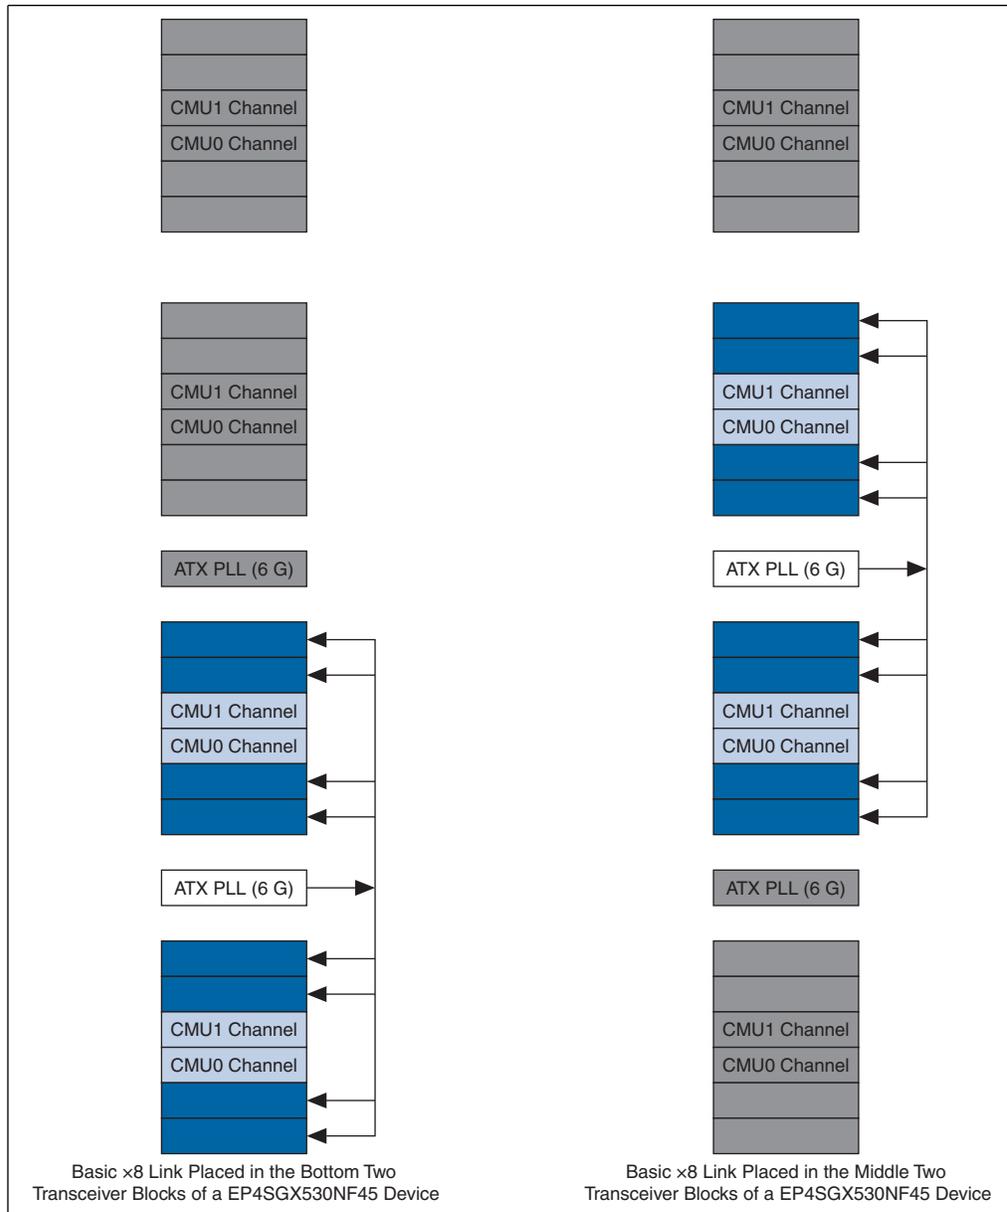
Figure 4. Placement Restrictions in Basic x8 Mode using ATX PLLs (6G)

The xN clock line timing issue in Stratix IV GX production devices affects the maximum data rate supported in the following transceiver configurations:

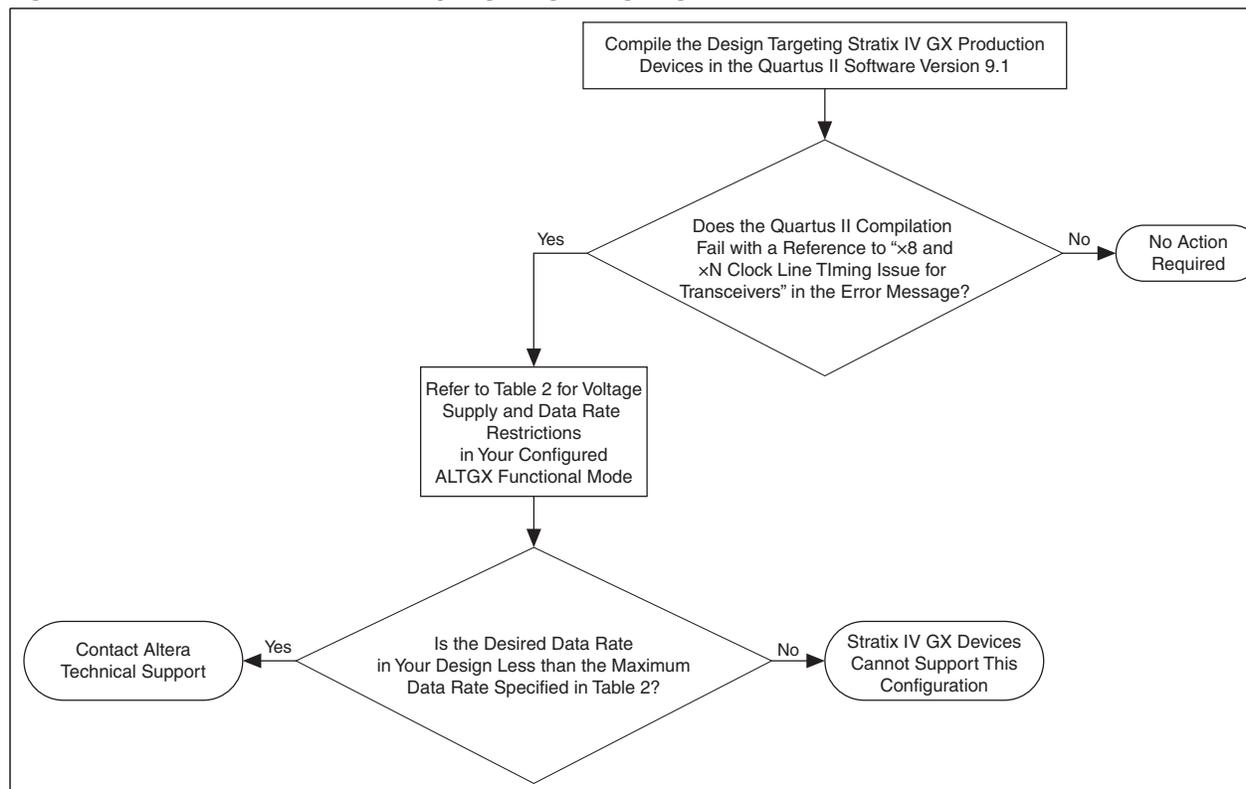
Figure 8. Recommended Flow When Compiling Designs Targeting Stratix IV GX Production Devices

For Stratix IV GX production devices, the Quartus II software version 9.1 does not implement the correct data rate restrictions shown in [Table 2](#).

Follow the recommended flow in [Figure 8](#) when you compile designs with the Quartus II software version 9.1 that target Stratix IV GX devices.

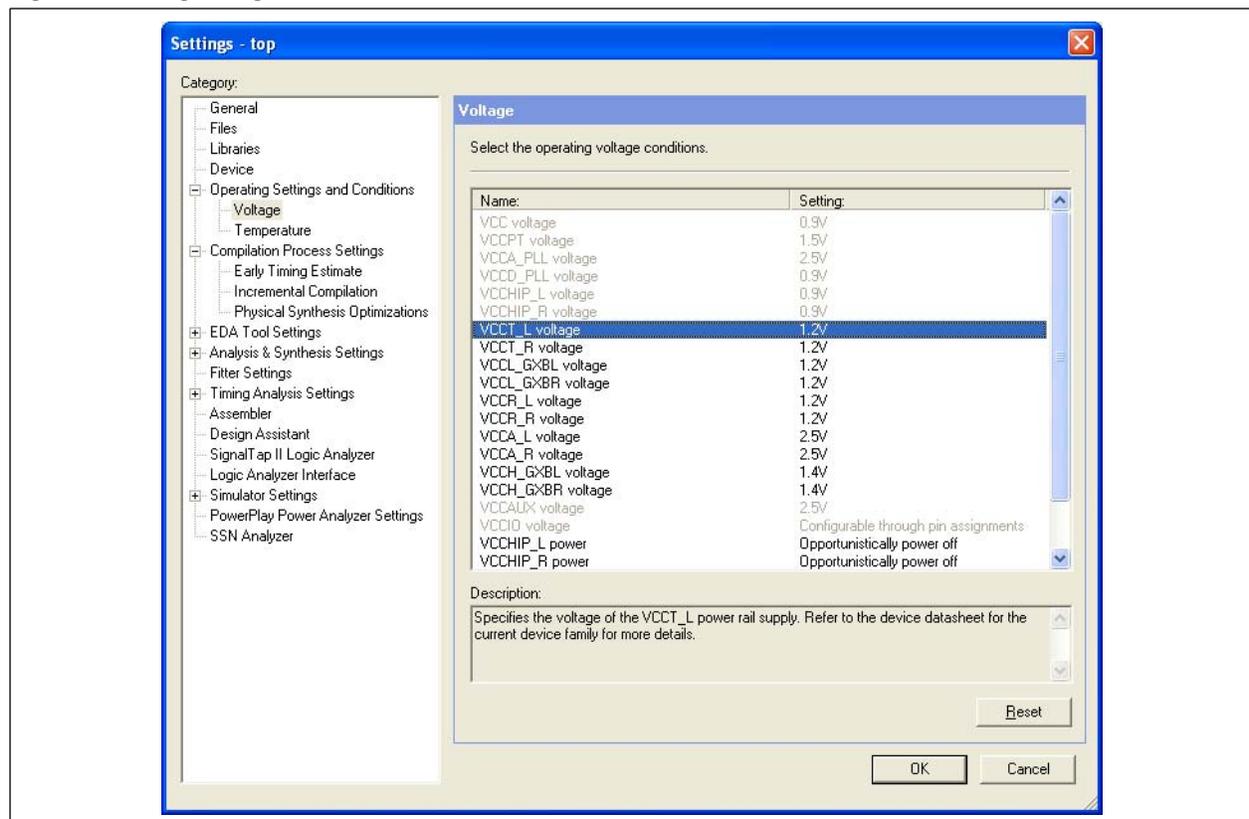
Figure 9. Setting Voltage Levels

- **Category 2:** The configured xN line data rate is greater than the maximum data rate supported by 1.1 V, but less than or equal to that supported by the 1.2-V power supply level specified in [Table 2](#).

Action: In the Quartus II software, on the Assignments menu, click **Settings**. Click the "+" icon to expand **Operating Settings and Conditions** and select **Voltage**. Set the **VCCT_L/R**, **VCCL_GXBL/R**, and **VCCR_L/R** voltage settings from **1.1V** to **1.2V**, as shown in [Figure 9](#). Then recompile the project.

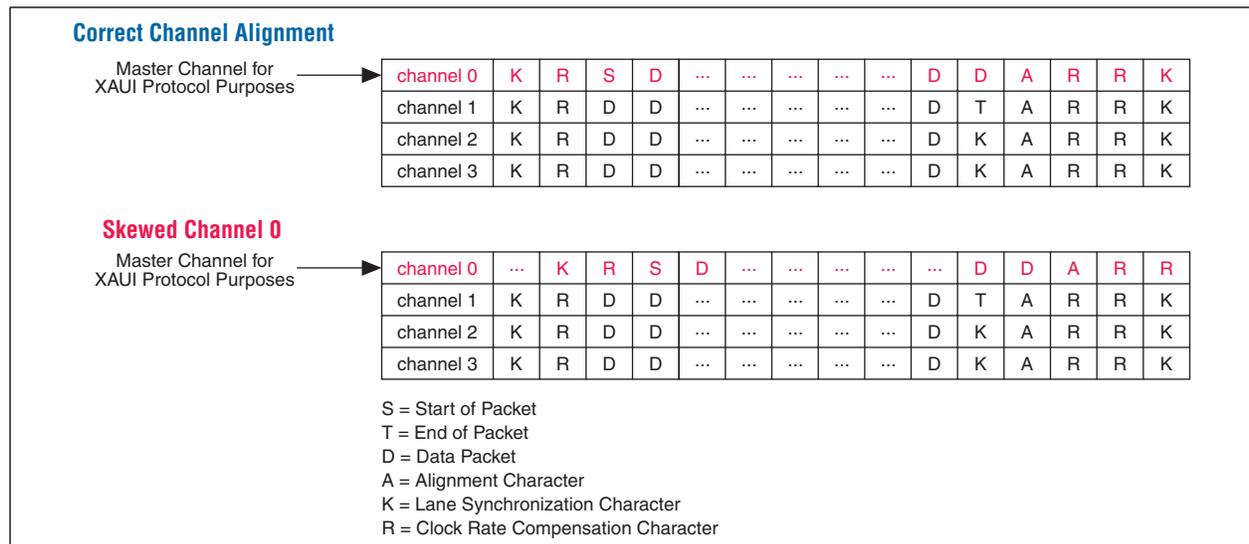
Figure 10. Rate Match FIFO Skew

In XAUI functional mode, the data out of the physical transceiver channel 0's Rate Match FIFO may be shifted by one byte with respect to the data of the other three channels. This shift causes incorrect idle ordered set conversion, resulting in incorrect received parallel data. The corrupted received parallel data caused by improper idle ordered set conversion or rate matcher corruption happens only during initialization or receiver channel reset (assertion of rx_analogreset or rx_digitalreset).

Figure 10 shows the channel skew.

Altera provides a soft IP solution and associated documentation, available for download at: www.altera.com/patches/xau-softip/xau-softip-fix-reva.zip

Integrate this soft IP into the XAUI receiver data path.
