TSB41BA3 Errata

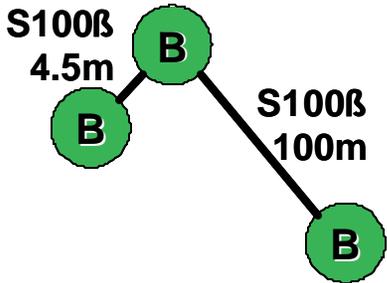
ERRATA ID	PROBLEM DESCRIPTION	RESOLUTION / WORK-AROUNDS
<p>1. BOSS Arbitration Issue</p>	<p><u>Symptom</u> A bus-reset may occur in certain topologies when 1394b BOSS arbitration is in use.</p> <p><u>Occurrences</u> This issue is only possible if three or more BOSS-arbitration capable nodes are connected through a 1394b connection. To be BOSS-arbitration capable a node must have a 1394b PHY and a 1394b Link using the 1394b PHY-Link interface connection.</p> <p>If a narrow timing window is violated (dependent on cable lengths and/or mixed speed bus hops), then a middle node may detect a packet collision, causing a state-timeout. The state timeout causes a bus reset. Repetitive occurrences result in repetitive bus resets.</p> <p><u>Example Topologies</u> A) Mixing short and long cable lengths. A BOSS arbitration issue may occur in the middle node:</p>

<p>A. Use 1394a Link Layer Controllers. If the network only consists of nodes using 1394a Link Layers, then BOSS arbitration is not utilized; gap delays are maintained and therefore are not affected by this errata.</p> <p>B. In nodes that do not have a link, dsable BOSS arbitration (e.g., force the BMODE pin to the logic 0 state).</p>

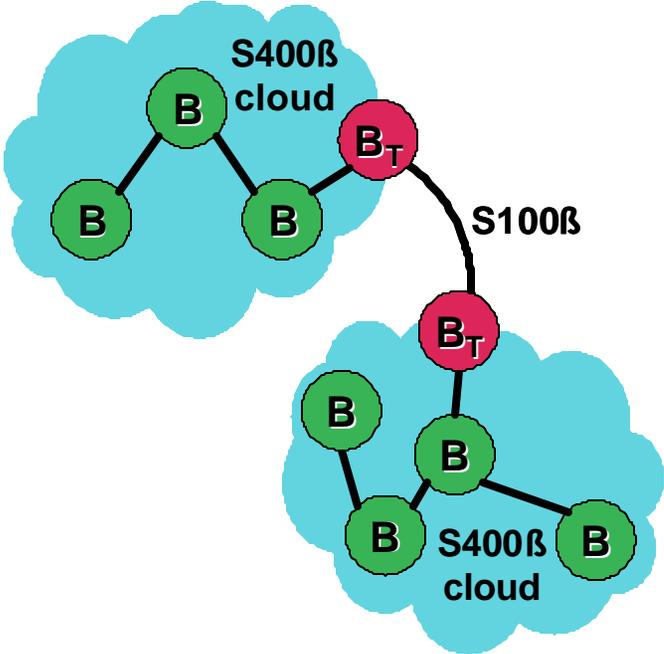
ERRATA ID	PROBLEM DESCRIPTION	RESOLUTION / WORK-AROUNDS
	<p>B) Mixing bus hop speeds. Either transition node (“B_T”) may have a BOSS arbitration issue:</p>

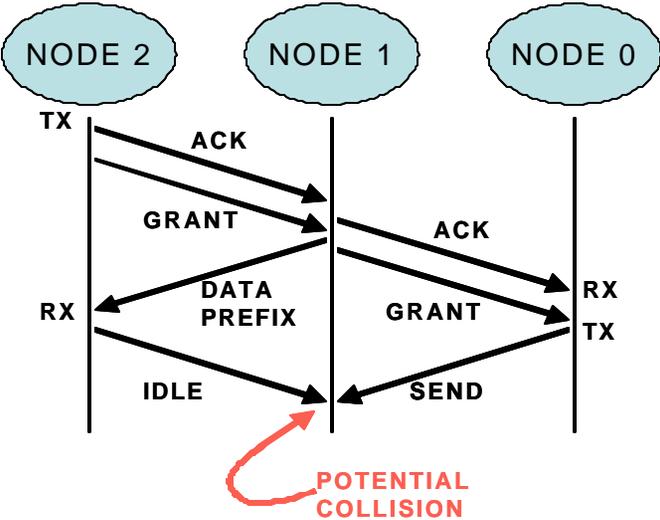
<p><u>Detailed Example Situation</u> Refer to the diagram below.</p> <ol style="list-style-type: none"> 1. Node #2 transmits a high-speed packet that ends an Async Subaction or the Isoch period. 2. Node #2 advances the Async phase (no requests pending for the current phase). 3. Node #0 has a bus request pending for the new phase. 4. Node #2 sends an Async grant.

ERRATA ID	PROBLEM DESCRIPTION	RESOLUTION / WORK-AROUNDS
	<p>5. The Async grant is forwarded through a senior node (Node #1) and down through a junior connection to Node #0.</p> <p>6. If a narrow timing window is violated, then the middle node (Node #1) will detect a packet collision, causing a state-timeout while forwarding the grant to the next node. The state-timeout will cause a bus reset.</p>
